- ~27 m3 of settled sludge transferred successfully from the fuel storage basin at the KE Reactor in preparation for D&D
- System/Equipment Problems caused delays in project execution
- Project Lessons Learned were compiled to relate the nature of the problems and how the problems were overcome

KBC-34834  
Revision 0  
EDC #: HNF-EDC-07-35133

## KBC Project Hose-In-Hose Transfer Project Lessons Learned

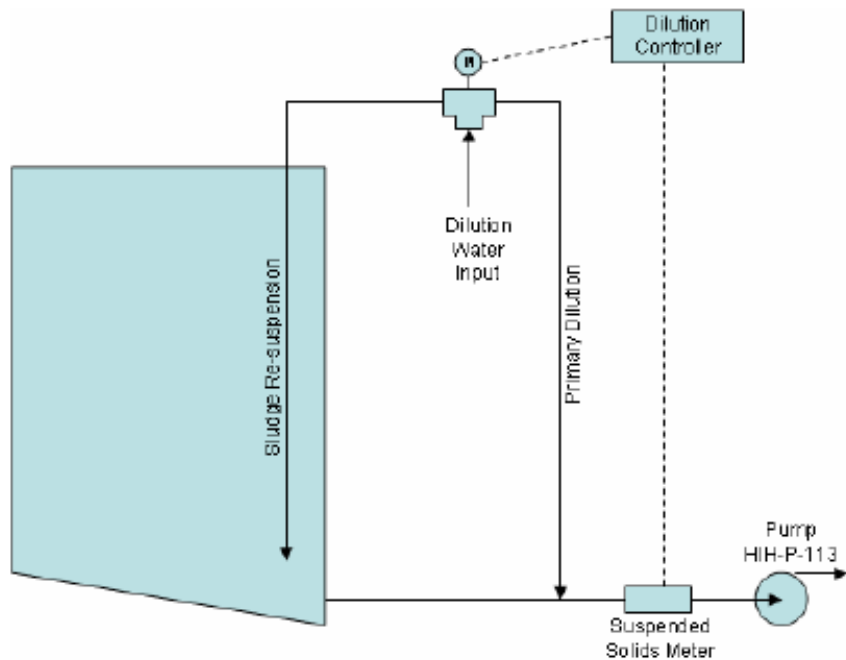
**Figure 3-11 System Configuration Before and After Addition of In-line Coarse Strainer**

- Construction Changes approved that moves dilution point further away from container (ease of operations issue)
- Foreign Material Inhibits suction line and fouls suction pump
- System trips due to insufficient suction pressure

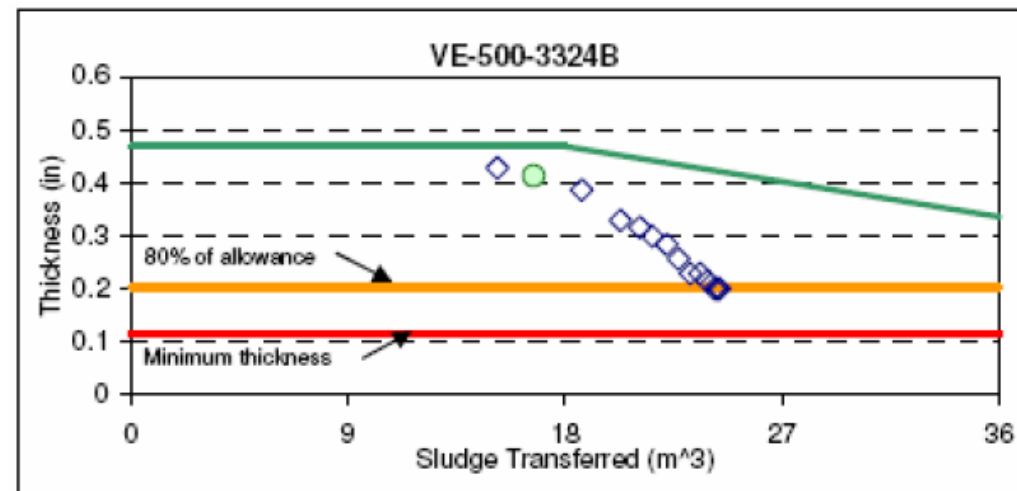
Figure 3-4 Worst Case Wear Location on HIH-P-332

## Underwater Booster Pump experienced multiple wear failures
